A Brief History of Emery Dam

Chronology of the Failure of Emery Dam

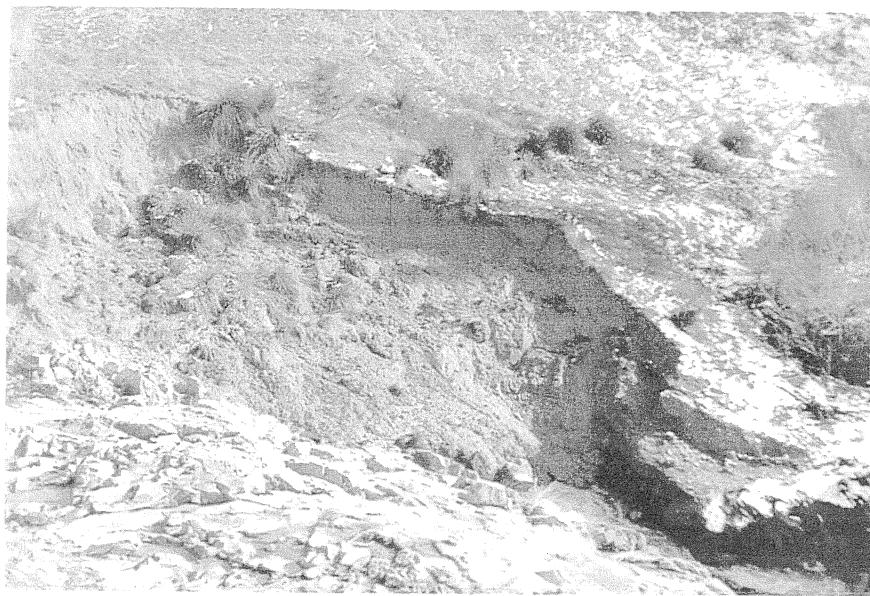
EMERY DAM, NO. 491
1/25/67 GHS

Sloughed area at toe of dam showing the amount of material that has been eroded away.

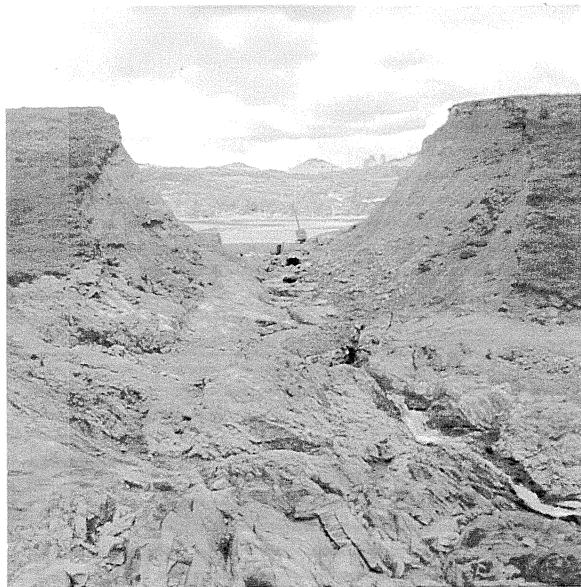
EMERY DAM AND RESERVOIR, NO. 491
5/11/67 GHS

Breach showing extent of sloughing on the sides.

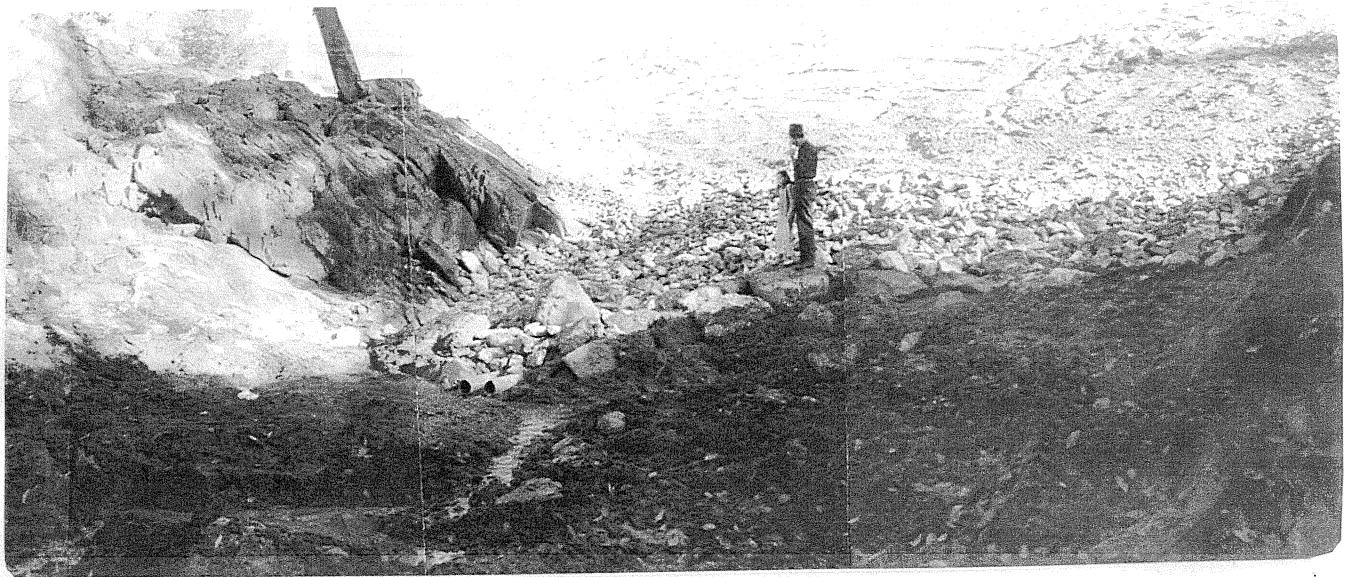
Toe area after placement of the riprap protection.

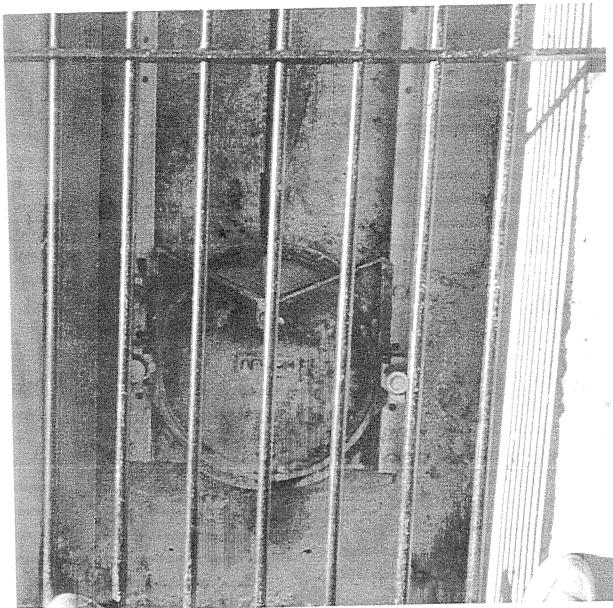
Outlet headgate.

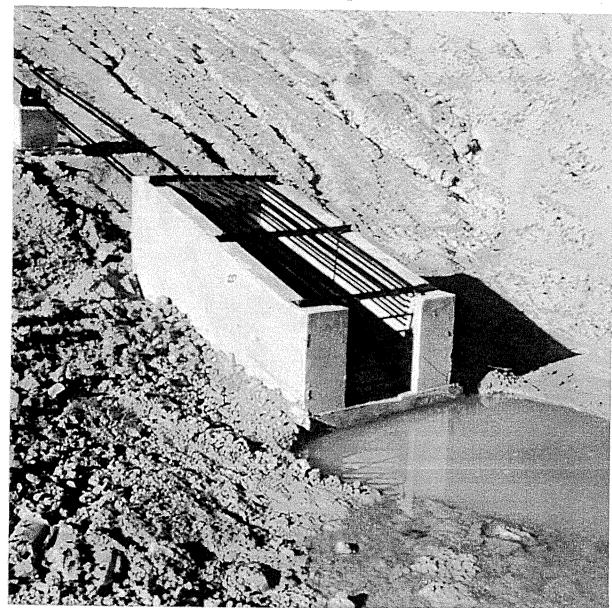
Outlet inlet structure.

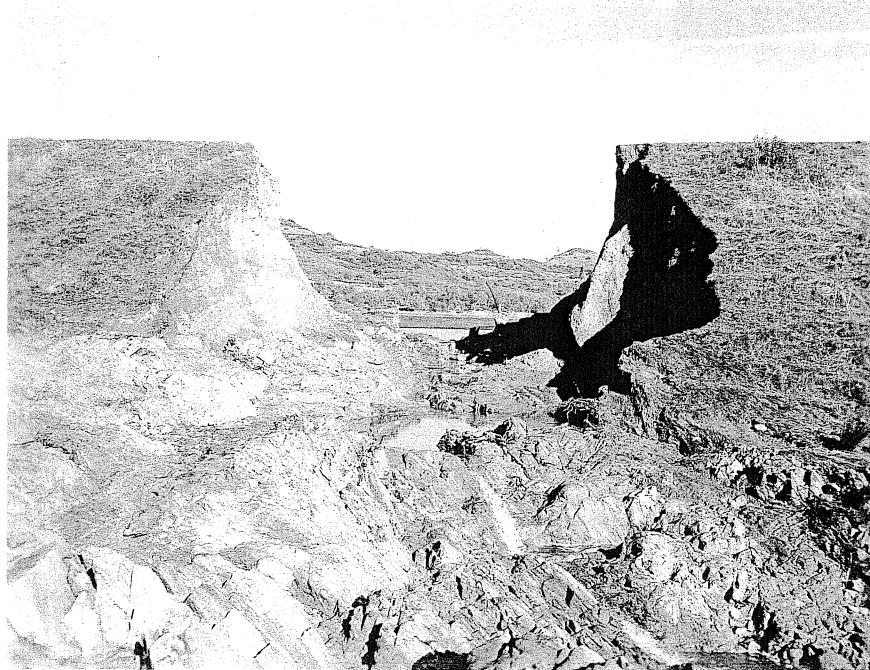
View looking upstream through breach.

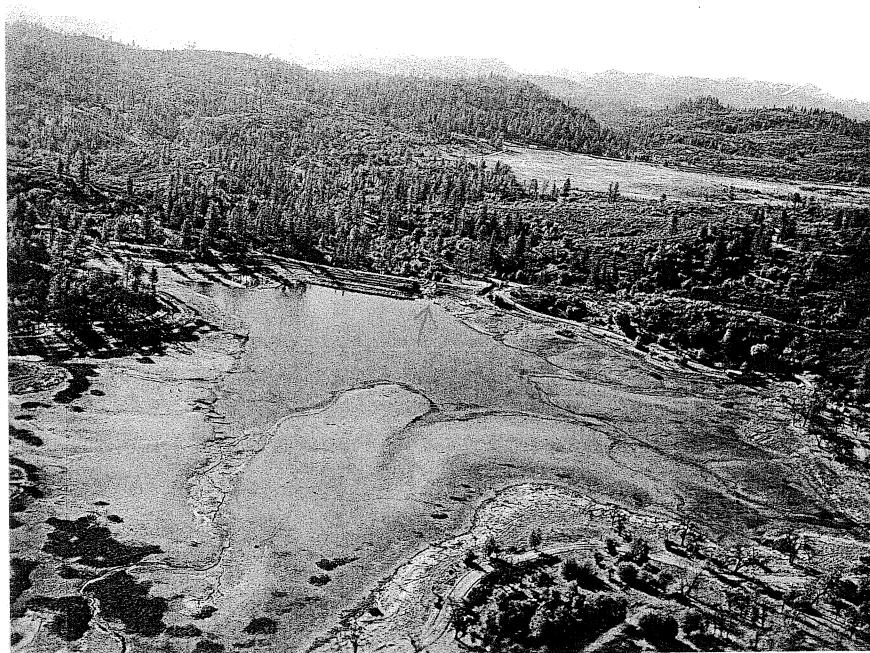
View of breached dam and reservoir.
