V. Background

VI. Results

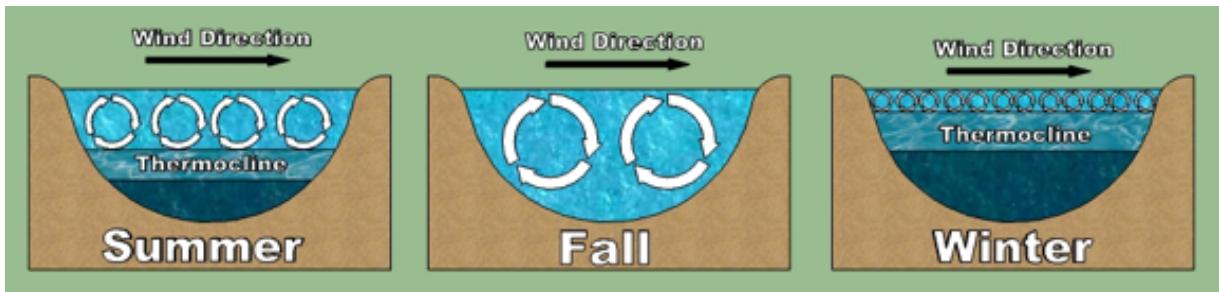
Figure 4: Lake turnover

Turnover occurs when the warm water that floats above the thermocline begins to cool and sink to the bottom (Figure 4). Typically, this happens during the first cold spell in fall. As it sinks, it diminishes the thermocline and allows for the entire water column to circulate (turn over). Throughout the growing season, the decomposers use up much of the dissolved oxygen in the benthic and profundal zones, which can develop into anoxic conditions (low amounts of dissolved oxygen). The cooler, denser, oxygen-depleted water may also have high levels of nutrients, methane, and hydrogen sulfide produced by the decomposition of organic sediments. This bottom water can be lethal to fish and as the water turns over it may cause fish-kills as it rises back up through the water column (Phillips et al., 2000).

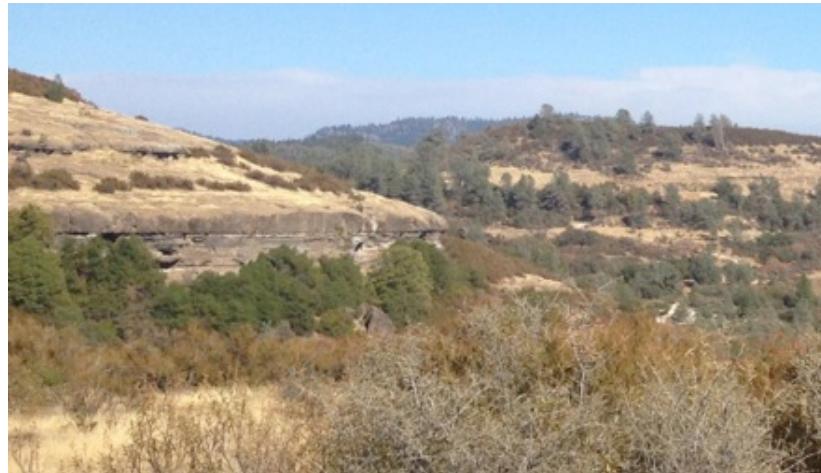
Picture 5: Sandstone cliffs surrounding Emery Reservoir

The watershed's topsoil consists of the latter series and is classified as the Mehrten and Valley Springs geologic formations, which formed during the early to mid-Pliocene and late Miocene Epochs (2 to 24 mya) (Map 4 – pg 26). The result is a landscape of vertical sandstone cliffs that surround the reservoir at the higher elevations (Picture 5), with shales, alluvial deposits and conglomerates forming the lower portion of the hillsides that extend down to the reservoir (Arkley, 2009). These deposits consist primarily of rock and soil whose parent material is volcanic in origin and high in mineral and nutrient content (Fisher et. al., 1997).

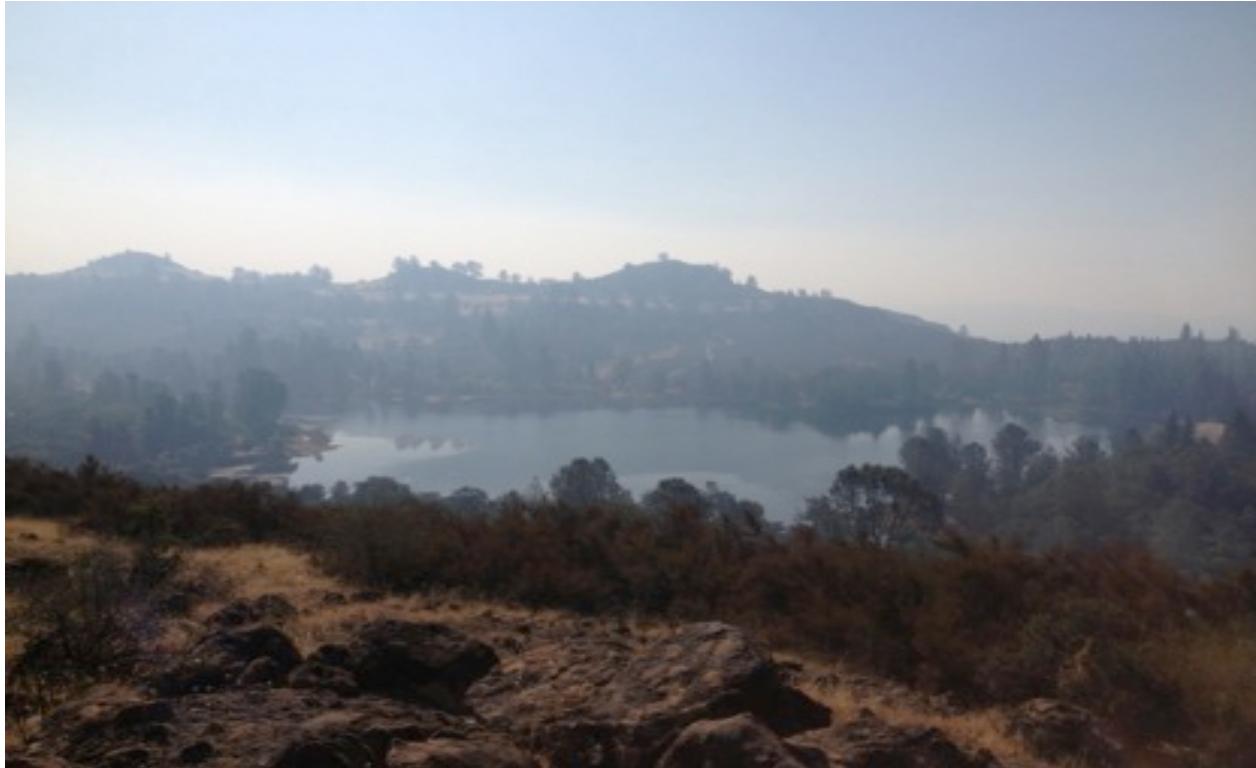
Picture 6: Smoke and ash from the Rim Fire. September 10, 2013

Total phosphorus (TP) measurements were identical at each sample site in the lake and were consistent throughout most of the study period. In August, there was a large spike in the levels due to ash settling on the water from a very large nearby forest fire, the Rim Fire (Picture 6). For this reason, those measurements are considered outliers and have been omitted from the calculation of the TSI. Throughout the first five months of the study period, TP measurements were 0.11 mg/L; for the last two months TP was 0.09 mg/L. Carlson's TSI requires measurements of TP in $\mu\text{g}/\text{L}$. After converting mg/l to $\mu\text{g}/\text{L}$, the value of the maximum and minimum TP becomes approximately 110 $\mu\text{g}/\text{L}$ and 90 $\mu\text{g}/\text{L}$, respectively.

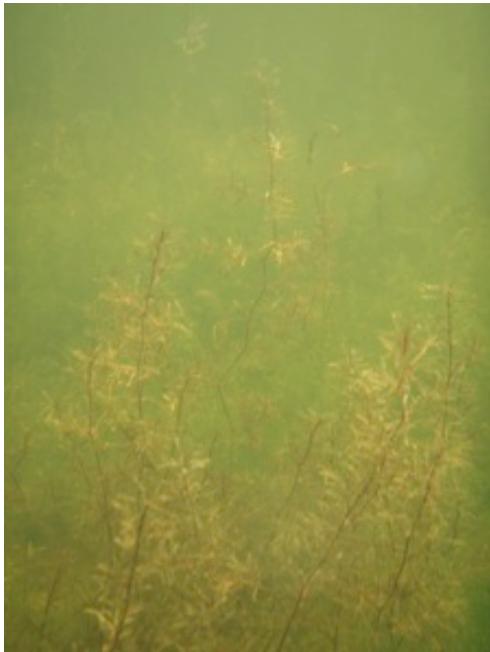
Picture 7: Stonewort Algae (Chara sp.)

Observation of algae and macrophyte abundance was viewed as a proxy for nutrient levels. While there was only a small amount of suspended algae in the limnetic zone (the center of the lake), almost the entirety of the littoral zone (near shore) was covered in dense, mat-forming algae like Stonewort (*Chara* spp.) (Picture 7) and Brittlewort (*Nitella* spp.) (Picture 7). These algae are often mistaken for plants because of their leaf-like appearances. In these shallower areas along the shore, filamentous green algae was also abundant enough to be mat-forming in certain areas (Picture 9).

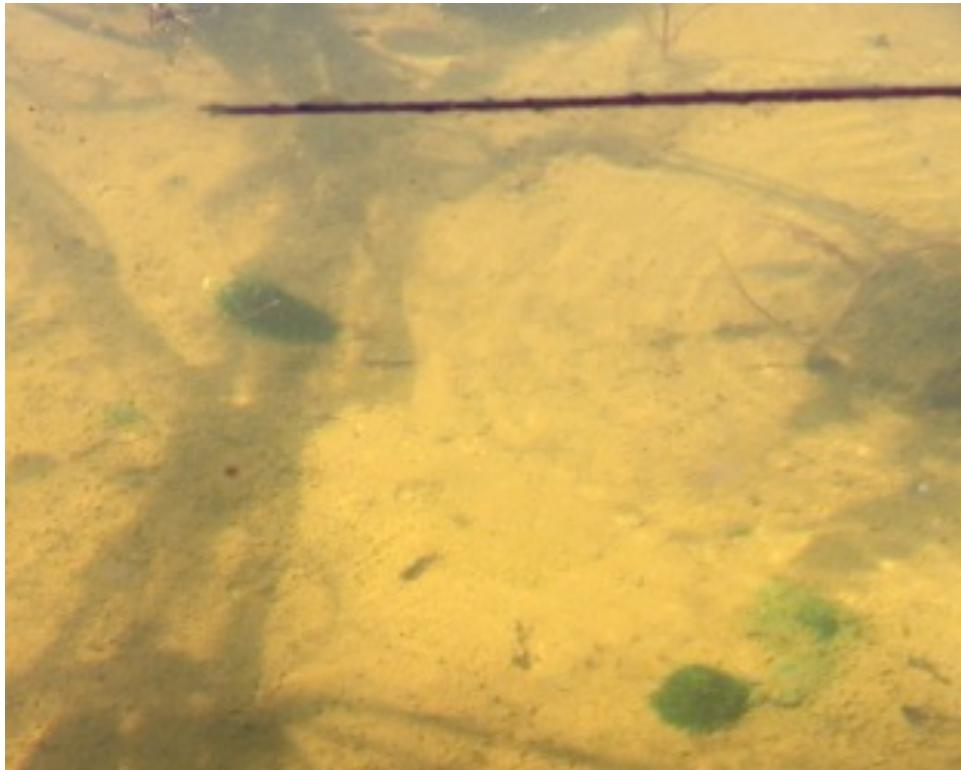
Picture 10: Cyanobacteria growing on sediment.

In addition to the green algae, there were several locations within the lake that were supporting colonies of cyanobacteria (blue-green algae), a telltale sign of a eutrophic lake (Holdren et al., 2001). These bacteria colonized on the bottom sediments and appeared as green circular spots (Picture 10). As the colonies grew, they produced and trapped gases that eventually cause them to dislodge from the bottom and float to the surface (Picture 11). Some strands of cyanobacteria can become toxic to animals; there have been reports of livestock and pets being killed from ingesting them, and humans may develop rashes or skin irritation if they come into contact with them.

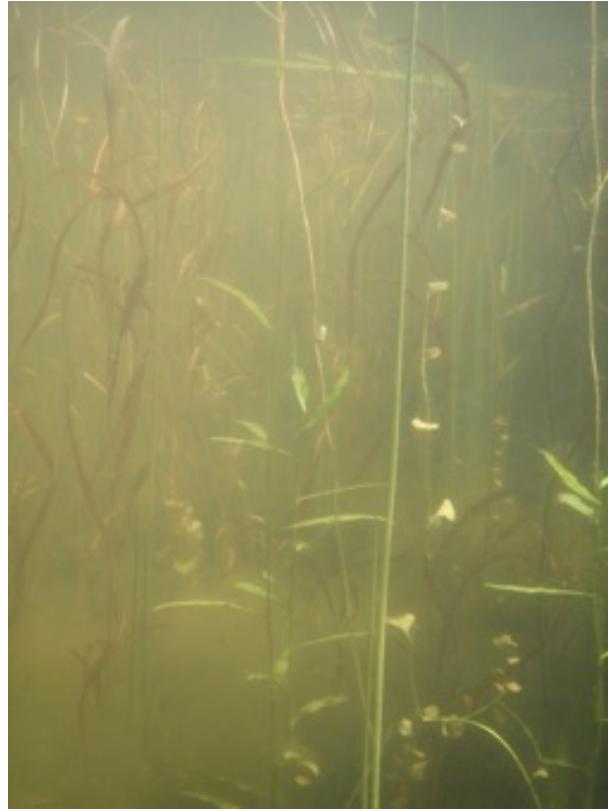
Picture 14: Underwater photo of mixed plant species

The observation of the lake-wide presence and high density of macrophytes and algae suggests that they constitute a large proportion of the nutrient budget within the reservoir.

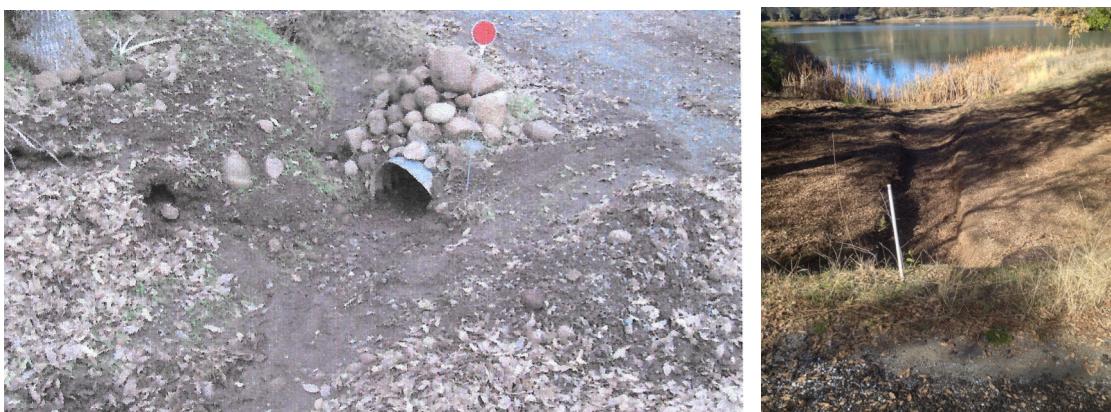
Picture 15: Sediment accumulation in Emery Reservoir's watershed, June 2013

Empirical observation of the culverts and creeks that lead to the reservoir show signs of extensive erosion. Sediment accumulation in areas near Lakeside Drive – the road encircling the lake – had filled in or buried several culverts (Picture 15, left).

The members of the HOA had removed vegetation from within the creeks and drainage ditches surrounding the lake in order to increase the volume and velocity of the water running through them (Picture 15 right). This exacerbated the amount of erosion occurring within these areas due to the increased exposure of unprotected soils. Additionally, as the velocity of a flowing waterbody increases, so does its ability to carry suspended sediment, and therefore it is likely that this practice increased the amount of sediment entering the reservoir. In periods of heavy rain that were observed on March 31st and September 21st of 2013, brown plumes could be seen emanating from where the creeks and drainage ditches entered the reservoir.
