I. Introduction

II. Study Area

Emery Reservoir (Picture 1) is a privately owned, man-made reservoir within the M-24 Ranch Association located in the Sierra Nevada foothills of California. This reservoir has progressed through the stages of eutrophication and now the overgrowth of aquatic plants has begun to interfere with boating, fishing, swimming, and other intended uses. If the residents and property owners of M-24 desire its continued use, they will require an LMP that addresses the site-specific causes of eutrophication.

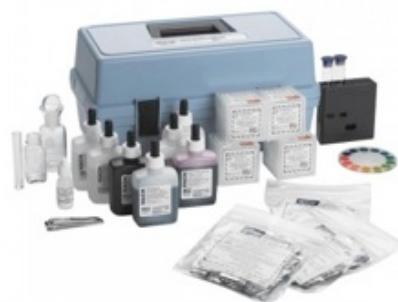
Picture 3: Hach test kit while

The following chemical and biological constituents were measured: dissolved oxygen, pH, nitrites, and phosphorus. The following test kits were purchased from the Hach Company in order to measure these variables:

1. Test Kit Water Ecology & Limnology Model AL-36B, Product # 180202rr

- Samples were immediately tested using the test kits in the canoe or transported in a cooler to shore.
- Results were recorded on paper and later entered into a spreadsheet.

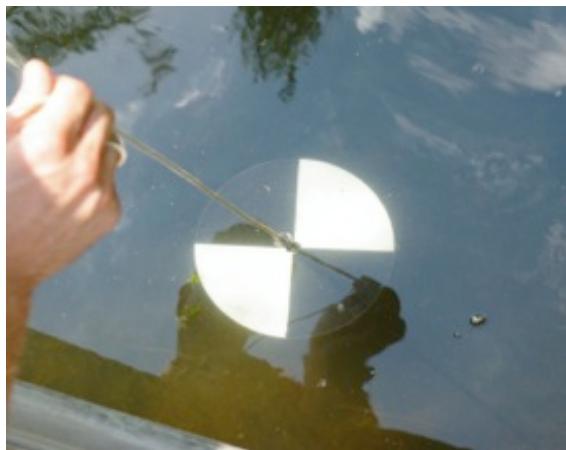
Picture 4: Secchi Disk

Visibility was obtained with a Secchi disk (Picture 4). This tool is a circular plate divided into quarters, with the color of each quarter alternating black and white. The disk is attached to a measuring tape and lowered into the water until it is no longer visible. It is generally accepted that the photic depth of a water column is 1.7 times the Secchi disk depth (Holdren et al., 2001).

- Secchi disk depth was only measured at the deepest sampling site – site 1.
 - Measurements were taken between the hours of 12:00 and 15:00, twice a month from March to September.
 - Results were recorded on paper and later entered into a spreadsheet.
